ALL MANIFOLD CONVERTERS

Sequential Torque & Tightening of Manifold Converter Bolts

Model(s): All engines with Manifold Catalytic Converters

Year: 1997 to present.

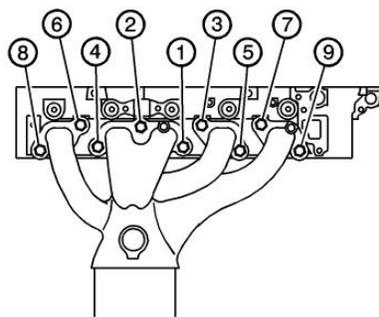
Condition: Unmetered air leaks or exhaust manifold gasket not sealing.

Cause(s): Improper tightening of the Manifold Converter Bolts

Solution: ALL Manifold bolts must be sequentially tightened and torqued to manufacturer's specs. These bolts should be tightened in four (4) stages in a spiraling pattern starting with the inner bolts working sequentially outward per the illustration below.

The first tightening should be to snug the bolts only and to check for proper new gasket alignment. The second tightening should be to 25% of the manufacturer specs. The third tightening should be to 75% and the last should be to 100%. All bolts should be checked and re-torqued after the first heat and cool down cycle.
