## 2007-10 Nissan Altima Manifold Converters

### Cracking of the Original Equipment & Replacement Manifold Converter

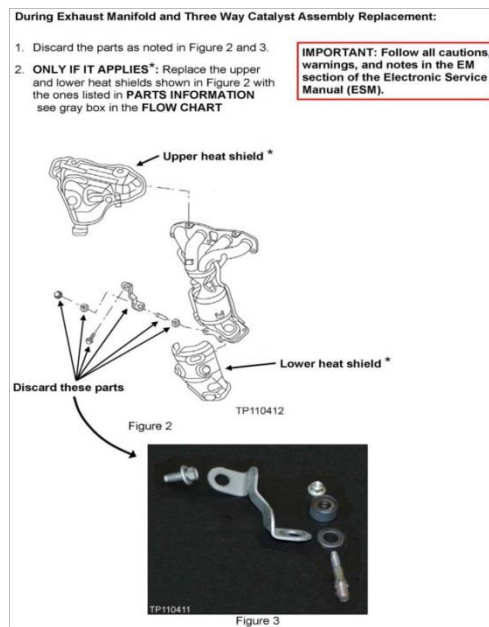
- Subject:** Cracking or fracturing of the Converter body or welds.
- Model(s):** Nissan Altima's with 2.5L engines
- Year:** 2007-10 Using our part number 18258
- Cause(s):** Excessive torquing and stress on the Manifold Converter.
- Solution:** Deletion of the manifold stay and related components attaching to the outlet flange of the manifold Converter
